Improving Reliability of Hydraulic Shears for Recycling Plant

Success Story

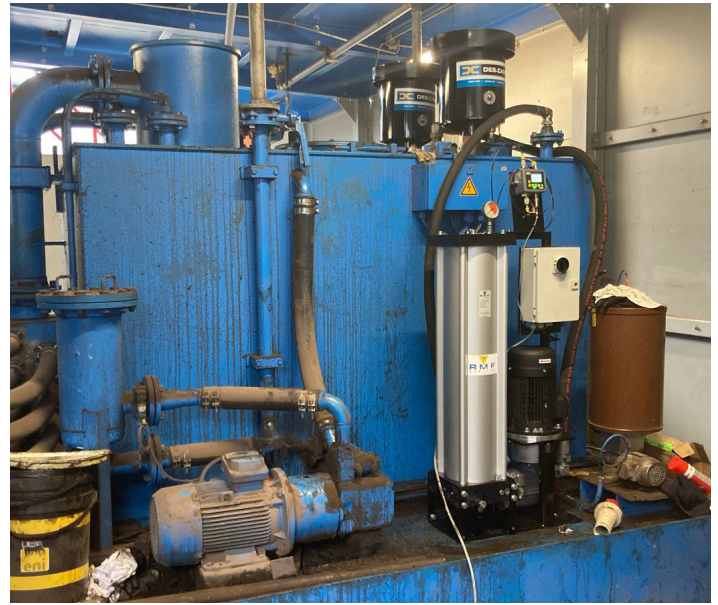
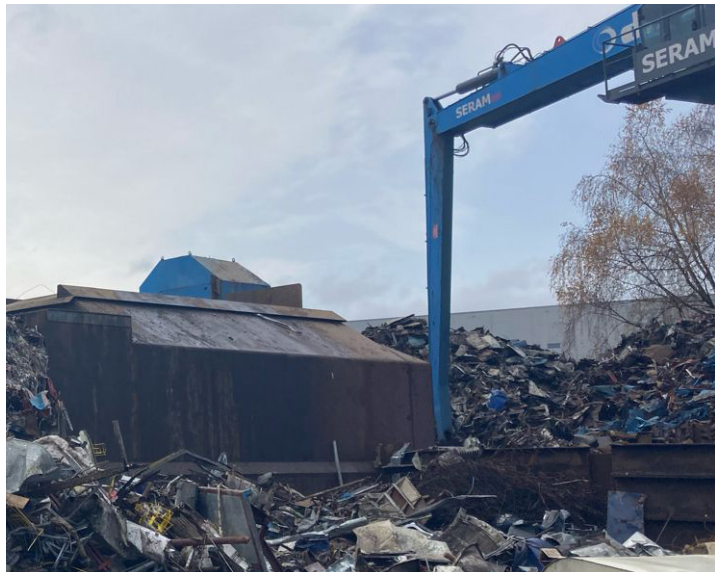
ISO 4406 Cleanliness Code Level

Before:

After:

24/23/17 to **12/9/0**

Thirty days after the installation of the GOLU, the ISO 4406 cleanliness code level improved to 12/9/0, a level not often found in hydraulic systems. During this period, two 92G 1-micron filter elements were used to achieve this cleanliness code. Additionally, the relative humidity level decreased from 91% to 30% as measured by the CMS.
